EPRI GS-7325  
Project 1745-15  
Final Report  
May 1991

# **Operation and Maintenance Experiences of Pumped-Storage Plants**

Prepared by  
MORRISON-KNUDSEN ENGINEERS, INC., San Francisco, California

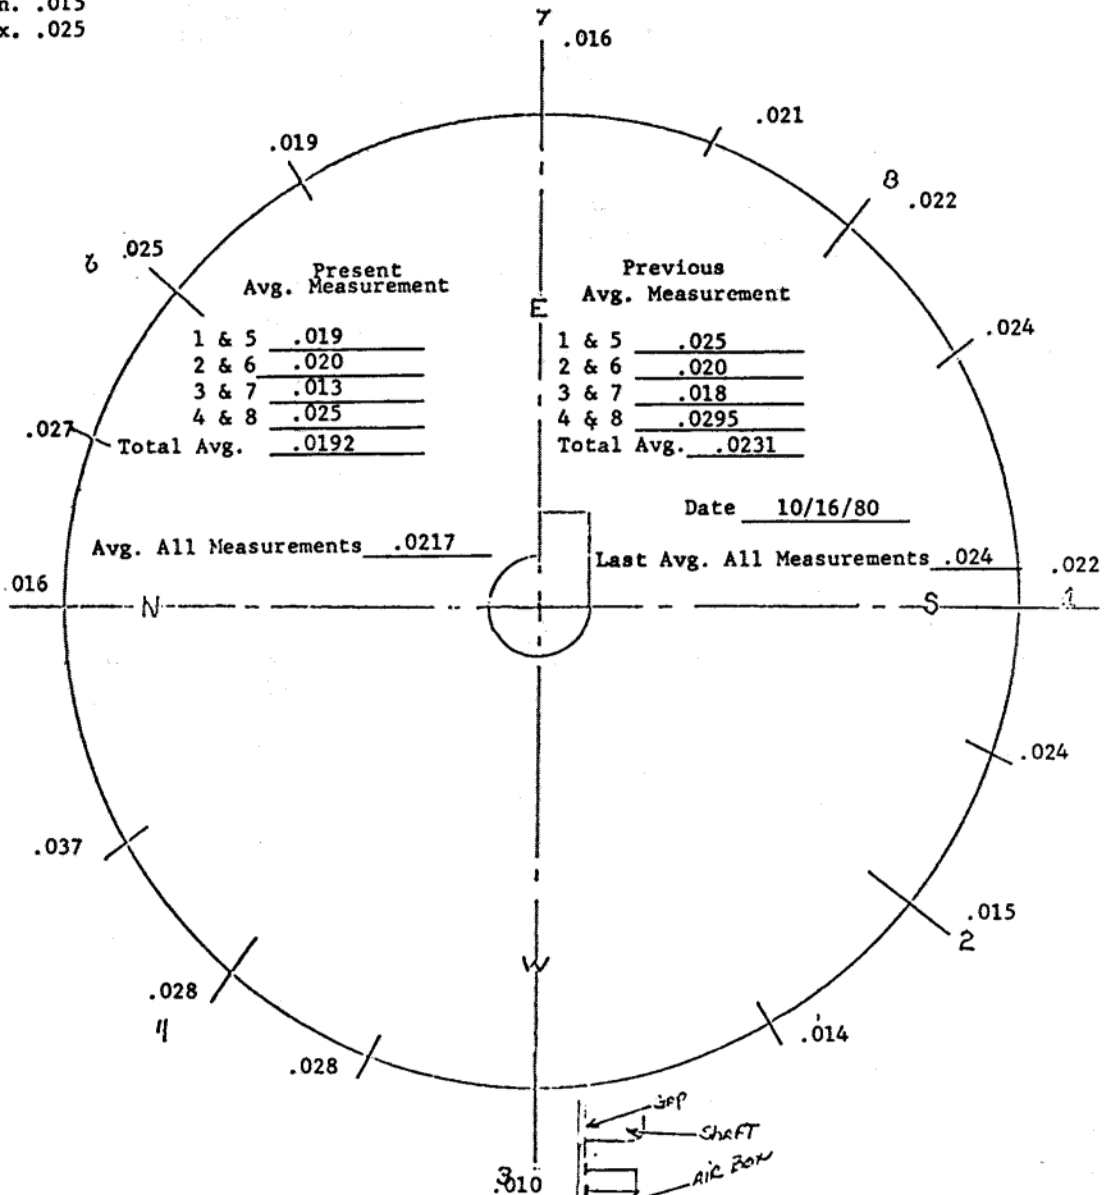
# Oil Sealing Box Gap At Shaft Thrust Brg.

Guide bearing air box gap was checked before and after bearing adjustment this gap was as shown on BG O & M 313 DATED: 10-14-81 & XXXXXXXXXX  
REMARKS: All found normal. Air box found with cracks around vent piping

Repaired crack in thrust bearing air box

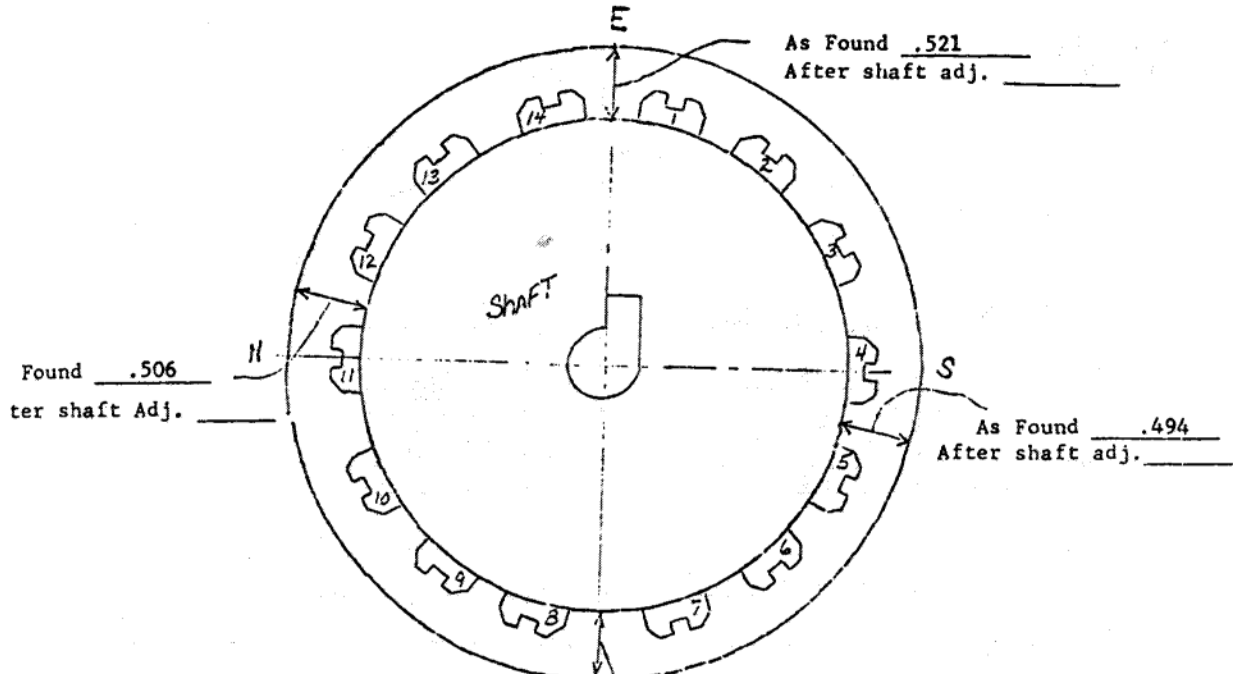
UNIT # 2  
Lower Guide Bearing Adjustment

Bearing #	As Found	Adjusted To		Bearing #	As Found	Adjusted To
1	<u>.009</u>	<u>N</u>	As Found <u>.4855</u> After shaft Adj. _____	8	<u>.009</u>	<u>N</u>
2	<u>.006</u>	<u>O</u>		9	<u>.011</u>	<u>O</u>
3	<u>.002</u>	<u>A</u>		10	<u>.014</u>	<u>A</u>
4	<u>.001</u>	<u>D</u>		11	<u>.016</u>	<u>D</u>
5	<u>.002</u>	<u>J</u>		12	<u>.016</u>	<u>J</u>
6	<u>.003</u>	<u>U</u>		13	<u>.015</u>	<u>U</u>
7	<u>.005</u>	<u>S</u>		14	<u>.012</u>	<u>S</u>
		<u>T</u>				<u>T</u>
		<u>E</u>				<u>E</u>
		<u>D</u>				<u>D</u>

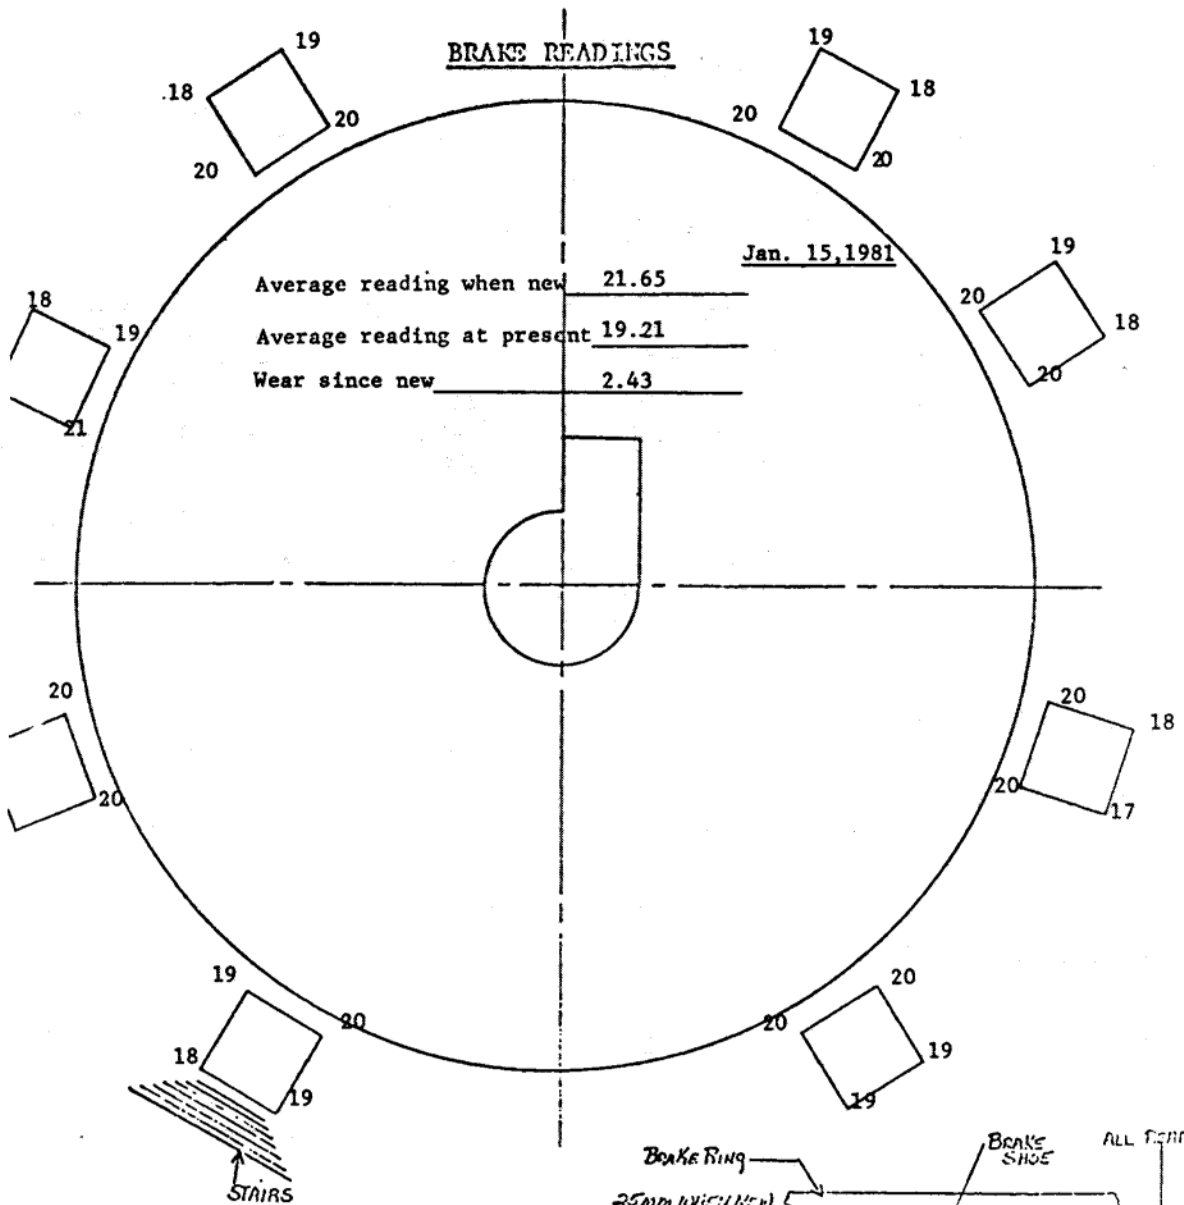
Unit # 2

Brakes should be replaced  
 when readings are 10mm, must  
 be replaced when readings are  
7mm on any one of the shoes

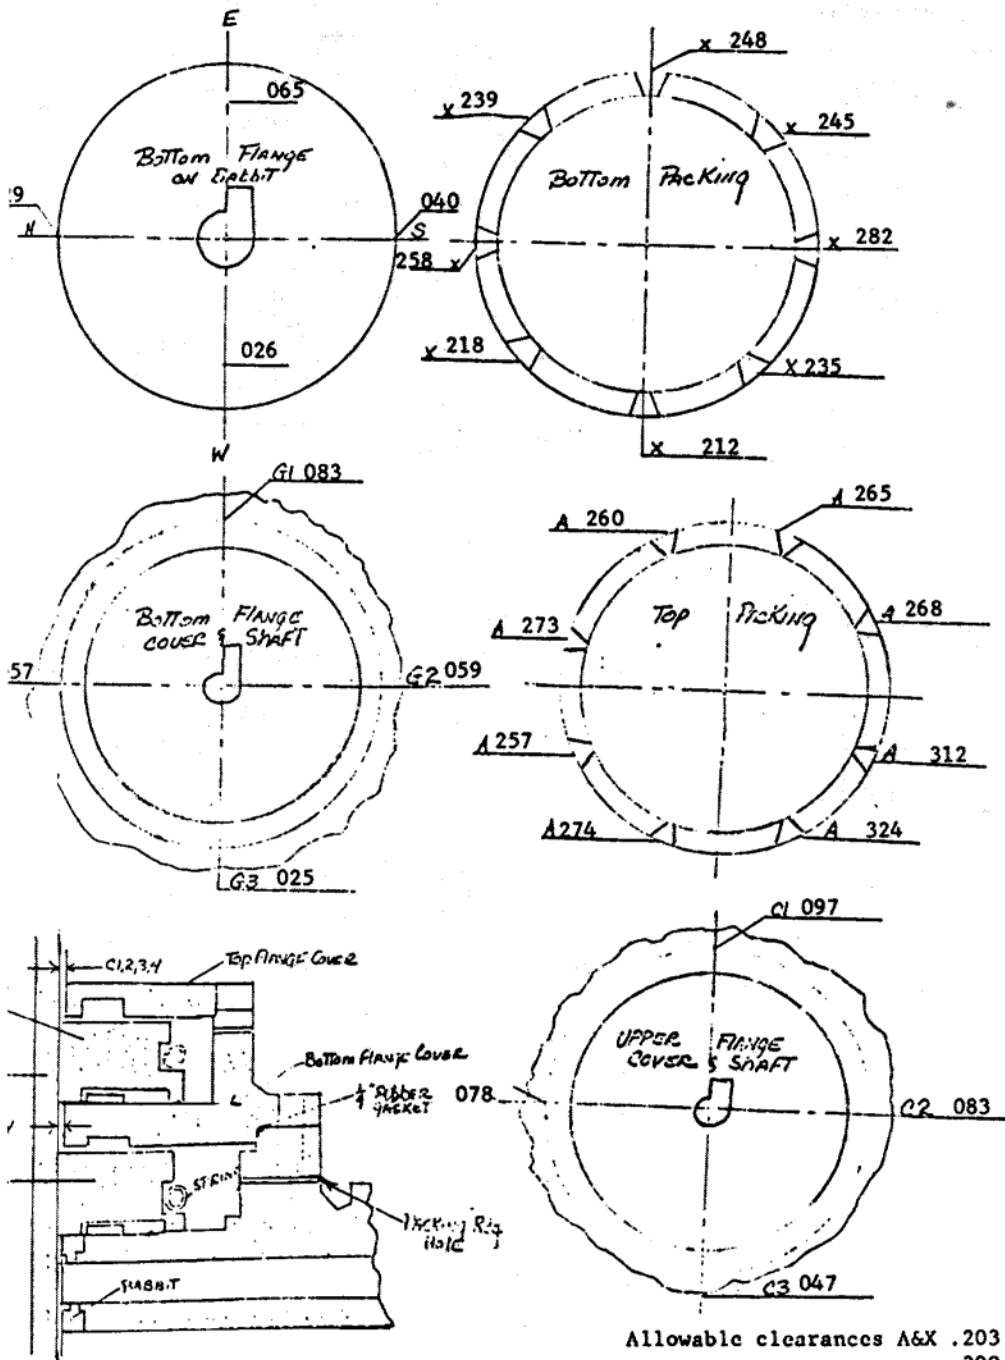
Unit # 2  
Before/After Changing the Packing (new packing)

Packing wear is shown on BG O & M 327 DATED: 10-20-81 O & M 322 DATED: 10-20-81 O & M 322 DATED: XXXXXXXXXX  
REMARKS: Resin worn 14% since new in 1980.  
Carbon worn 15% since new in 1980.

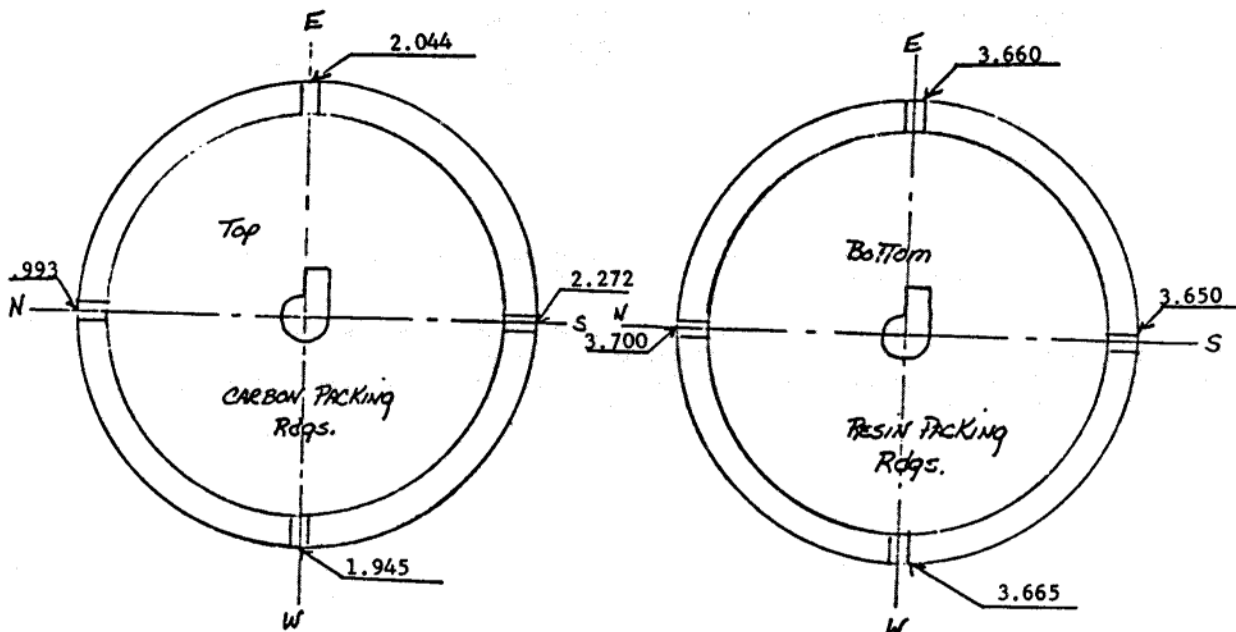
UNIT # 2  
PACKING WEAR READINGS  
(New)

Top - Carbon Average Rdgs	E&W 1.9945	Average 2.0635
	N&S 2.1325	
Bottom - Resin Average Rdgs.	E&W 3.6625	3.6687
	N&S 3.675	
Carbon New Average	E&W 1.898	1.889
	N&S 1.880	
Resin New Average	E&W 3.508	3.511
	N&S 3.515	
Amount of Wear - Carbon	E&W .0965	.1745
	N&S .252	
Amount of Wear - Resin	E&W .1545	.157
	N&S .160

23% % Carbon Wear  
21% % Resin Wear  
Total Run Since Packing Changed  
Resin Carbon  
Gen Hrs. 1796.9 Gen Hrs. 1796.9  
Gen Spin 29.2 Gen Spin 29.2  
Pump Hrs. 2199.9 Pump Hrs. 2199.9  
Pump Spin 14.8 Pump Spin 14.8

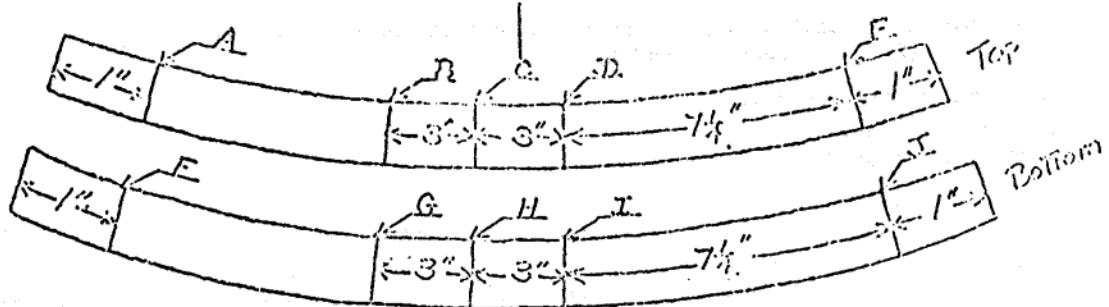
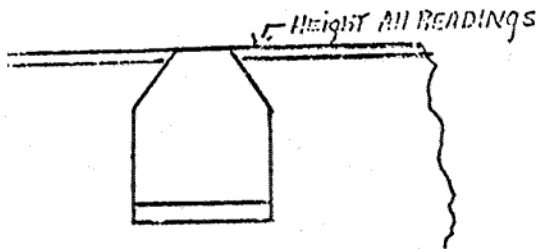
# WICKET GATE RUBBER SEALS

Wicket gate seal inspection defects show on BG O & M 324 DATED: 10-13-81

p. seals replaced: Seven, two were original seals installed with unit.

Lower seals replaced: Fourteen, two were original seals installed with unit.
